Windham Board of Education

School Facilities Existing Condition Survey & Master Plan

**WINDHAM BOARD OF EDUCATION – SCHOOL FACILITIES
EXISTING CONDITION SURVEY & MASTER PLAN
EXECUTIVE SUMMARY**

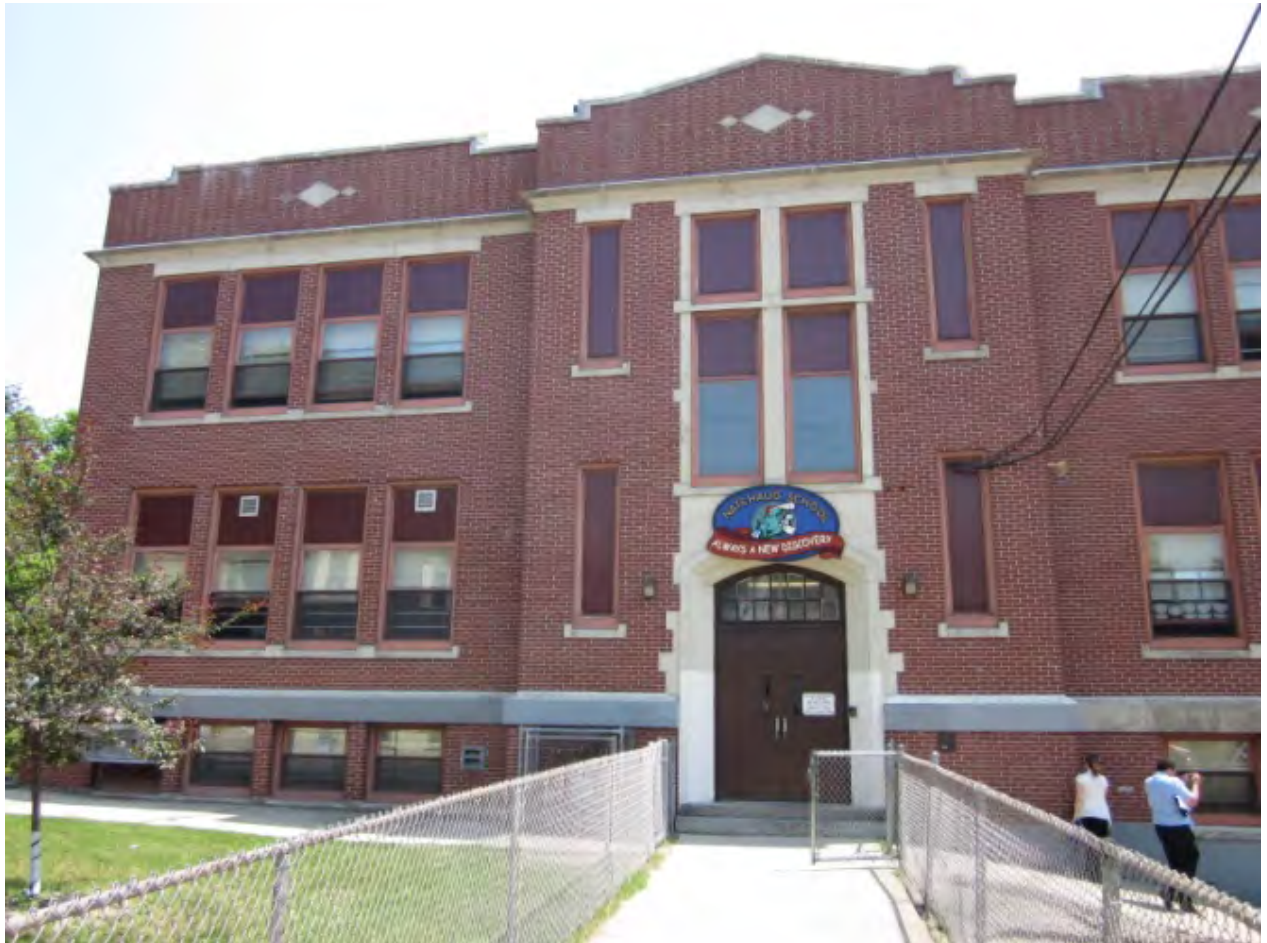
Natchaug School is housed in a three-story, 48,026 square-foot masonry building located at 123 Jackson Street in Willimantic. Originally constructed in 1914, the building received an addition in 1923 and serves Grades K - 5.

The "L shaped" building contains three stairwells and an elevator. Circulation in the original building is provided by a central corridor with a stairwell at each end. The addition also has a central corridor with a stairwell and elevator near the end.

Based on the survey, Natchaug School is in poor condition.

The exterior skin of Natchaug School is brick masonry, which is in poor condition. The roof consists of Spray Polyurethane Foam (SPUF) roofing, which is in poor condition.

Typical windows consist of double hung windows with wood or painted aluminum frames, and exterior doors are painted metal. The windows are in fair condition and the exterior doors are in fair condition. The exterior sealants of the doors and windows are in poor condition.

The building is typically constructed of masonry bearing walls and structural steel framing that is in fair condition. The roof is supported by structural wood framing with a wood plank roof deck. The foundation consists of a combination of reinforced concrete foundation walls and footings.

- Replacing the SPUF roof, restoration of the roof deck and roof framing.
- Hazardous material removal and installation of new replacement finishes.
- Brick masonry restoration and parapet wall restoration.

- Masonry parapet repair and restoration.
- Structural wood framing repairs, supplemental framing and replacement of deteriorated roof deck sheathing.
- Repair of exterior brick veneer at specific locations.

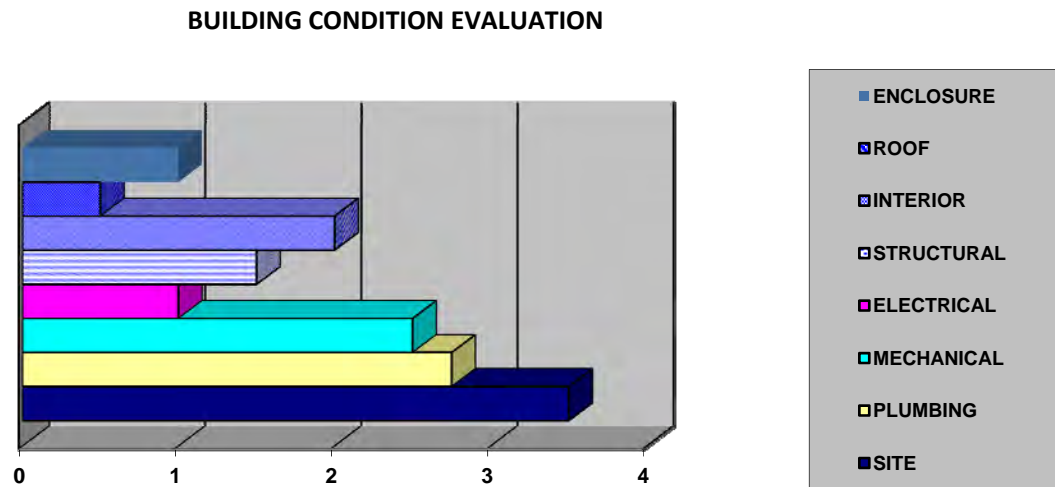
Each of the elements that were reviewed under this category was ranked on a scale of 0-4, with a 4 rating equating to excellent conditions. Components that received a ranking of 3 should be considered to be in good condition, while rankings of 2 and 1 are considered to be in fair and poor condition, respectively. The following chart graphically presents the survey results (reference Section 4 for a detailed description for each category).

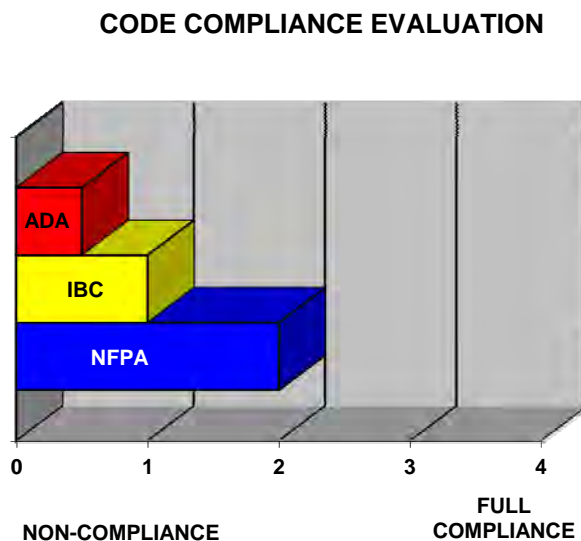
The graph below represents the building's overall conformity with IBC, NFPA and ADA requirements. Compliance was rated on a scale of 0-4, with a 4 rating equating to full compliance. A rating of 2 or under indicates that the building requires moderate to substantial code compliance updates in order to protect the safety of the building's occupants.

Note: The building contains many conditions that do not comply with applicable codes.

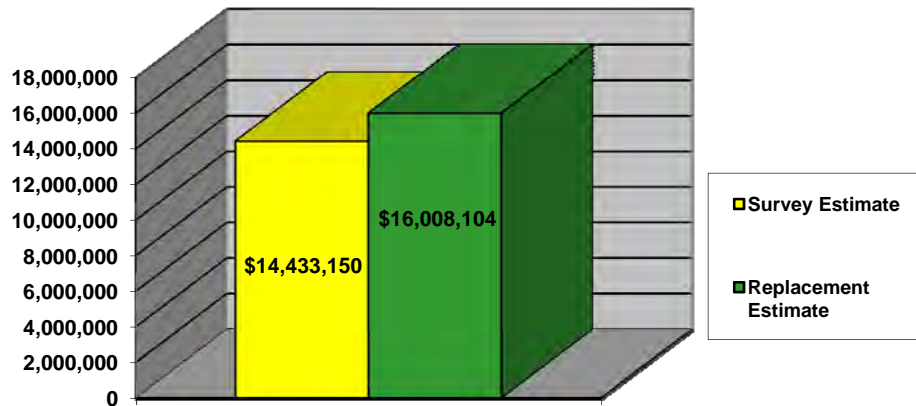
The chart below indicates the estimated value of the required work addressed by the building survey alongside the potential replacement cost. The replacement cost is provided as a guideline for comparative purposes and is based on replacing the building as is: size and use. Information considered includes the type of structure, year built and existing area for the building.

The required work addressed in this survey equates to approximately 90% percent of the Construction cost of an entire building replacement project. Site acquisition costs for a potential new building were not factored into this comparison.

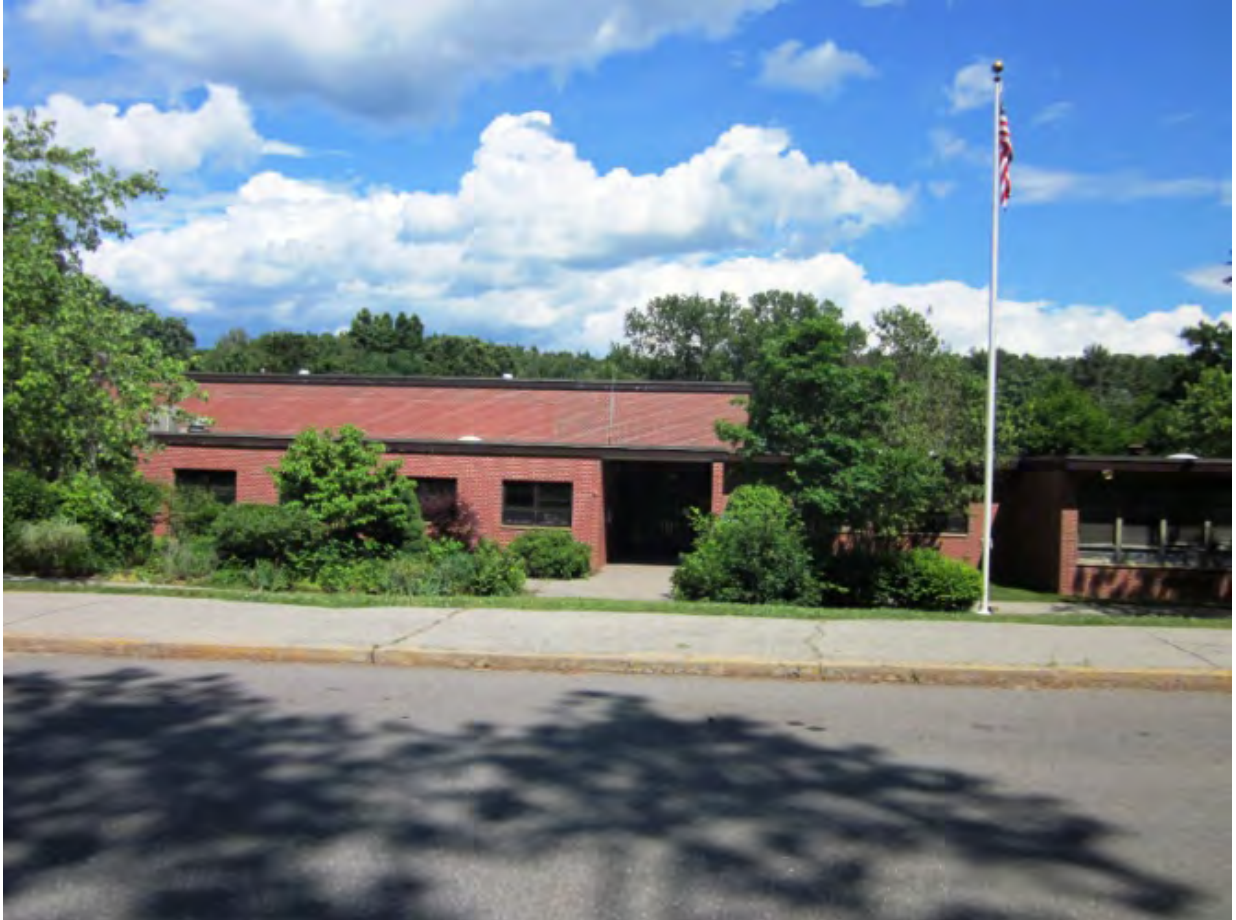
North Windham School is housed in a one-story, 48,876 square-foot building located at 112 Jordan Lane in North Windham. Originally constructed in 1959, the building received an addition in 1974 and serves Grades K - 5.

The building was constructed slab on grade and therefore contains no stairs. Circulation is provided by a central corridor with two auxiliary corridors with ramps.

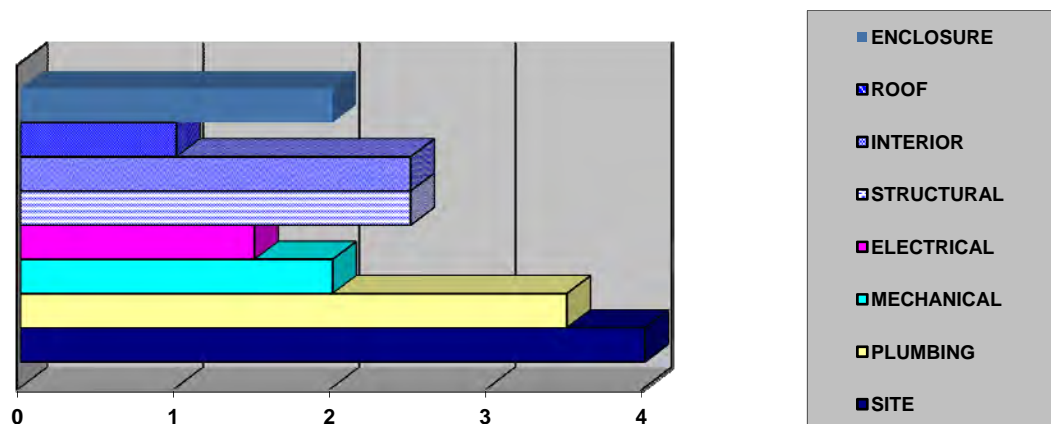
BUILDING CONDITION EVALUATION

Scale: 1 = Poor Condition, 4 = Excellent Condition

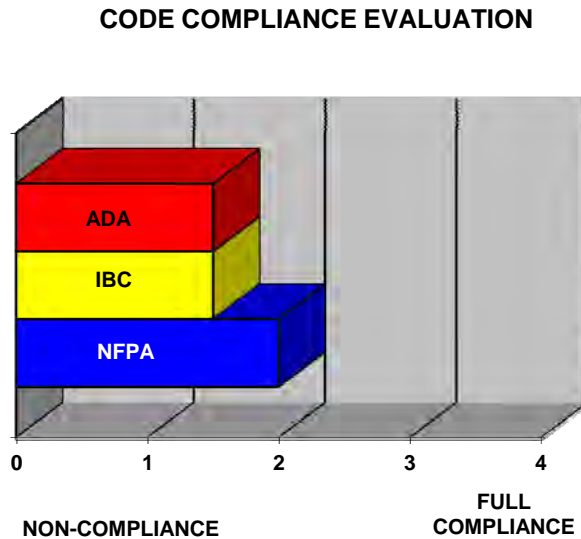
The graph below represents the building's overall conformity with IBC, NFPA and ADA requirements. Compliance was rated on a scale of 0-4, with a 4 rating equating to full compliance. A rating of 2 or under indicates that the building requires moderate to substantial code compliance updates in order to protect the safety of the building's occupants.

Note: The building contains conditions that do not comply with applicable codes.

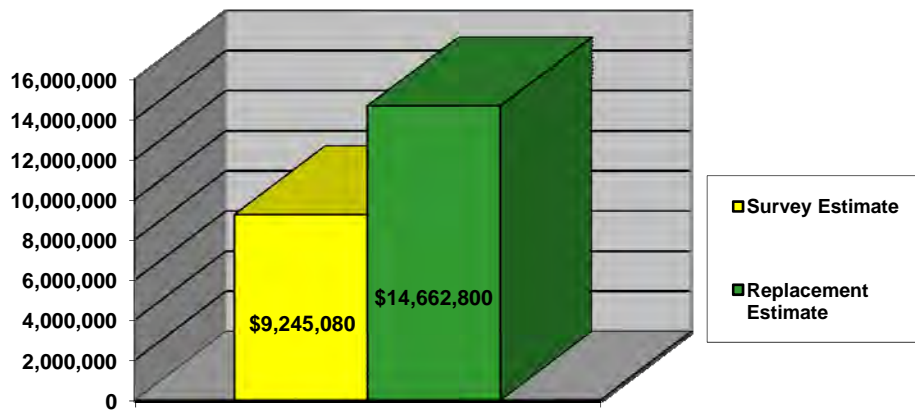
The chart below indicates the estimated value of the required work addressed by the building survey alongside the potential replacement cost. The replacement cost is provided as a guideline for comparative purposes and is based on replacing the building as is: size and use. Information considered includes the type of structure, year built and existing area for the building.

The required work addressed in this survey equates to approximately 63% percent of the Construction cost of an entire building replacement project. Site acquisition costs for a potential new building were not factored into this comparison.

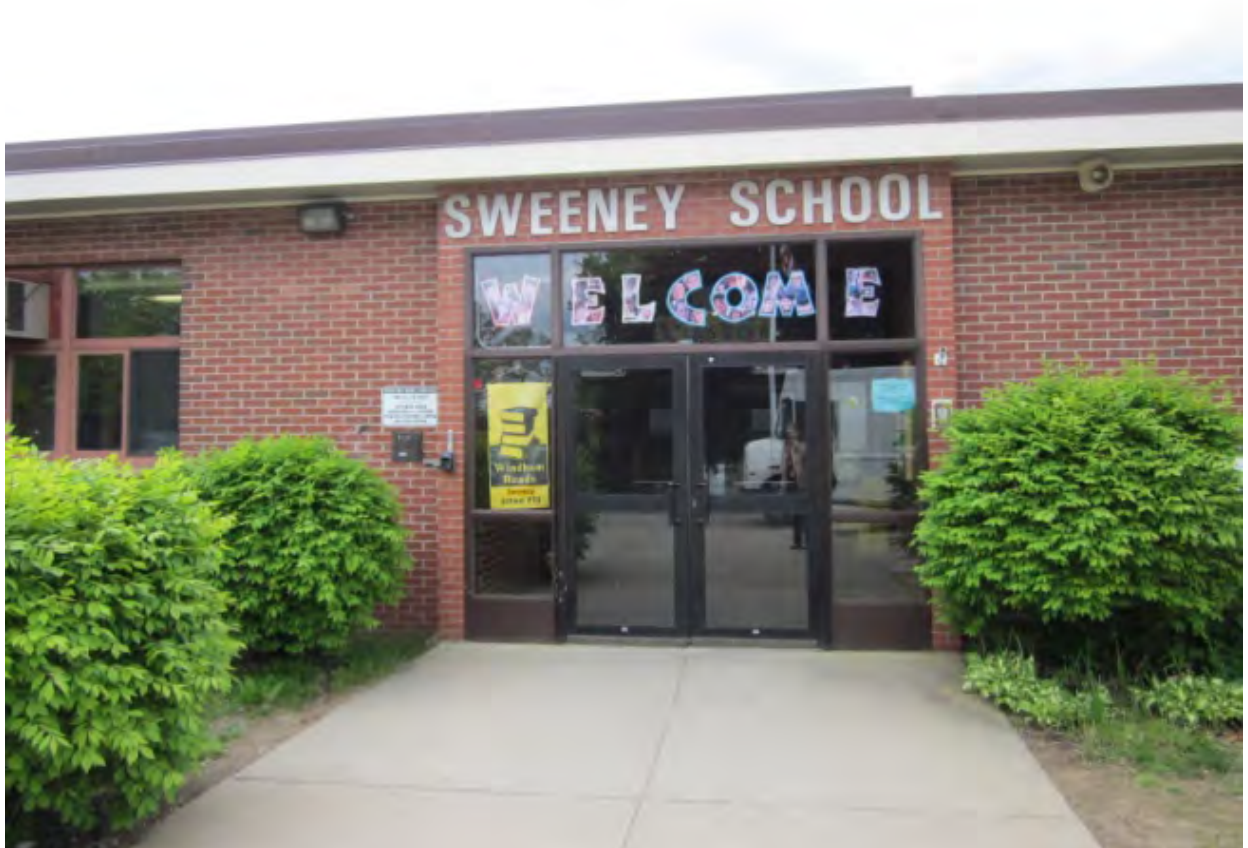
W. B. Sweeney Elementary School is housed in a one-story, 43,000 square-foot building located at 60 Oak Hill Drive in Willimantic. Originally constructed in 1959, the building received an addition in 1963 and serves Grades K - 4.

The building was built slab-on-grade, and therefore, does not contain any means of vertical circulation for students and faculty. Circulation provided by a central egress corridor with several means of egress.

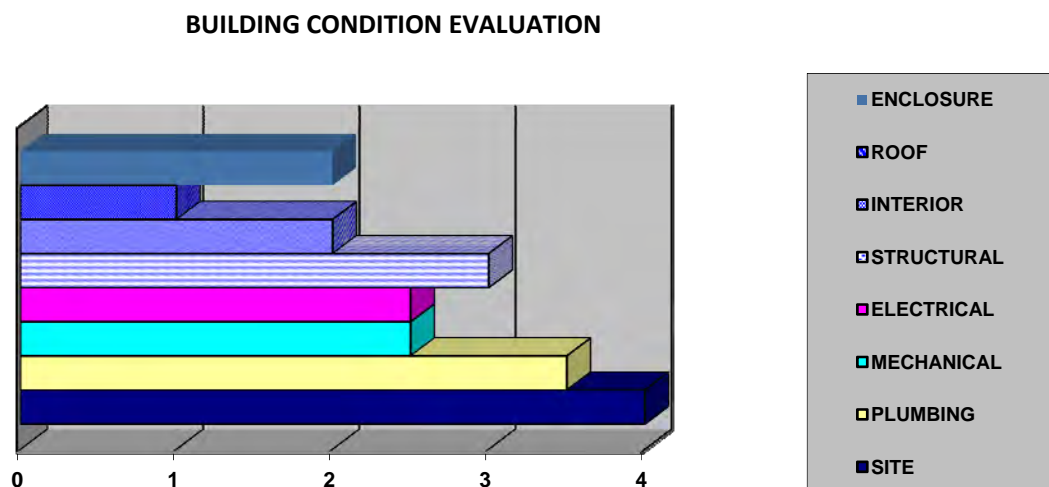
Each of the elements that were reviewed under this category was ranked on a scale of 0-4, with a 4 rating equating to excellent conditions. Components that received a ranking of 3 should be considered to be in good condition, while rankings of 2 and 1 are considered to be in fair and poor condition, respectively. The following chart graphically presents the survey results (reference Section 4 for a detailed description for each category).

Scale: 1 = Poor Condition, 4 = Excellent Condition

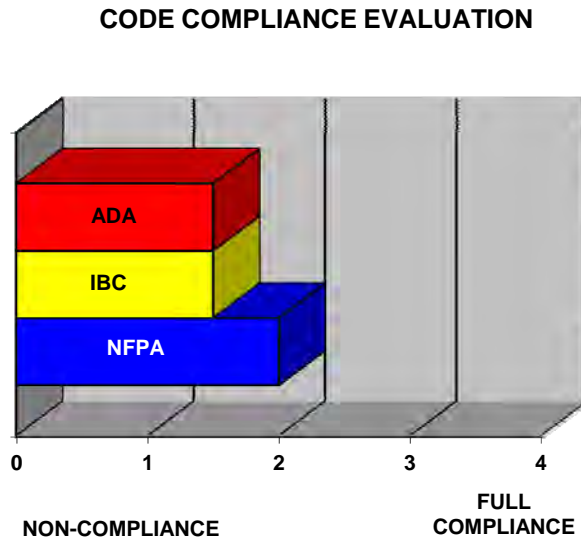
The graph below represents the building's overall conformity with IBC, NFPA and ADA requirements. Compliance was rated on a scale of 0-4, with a 4 rating equating to full compliance. A rating of 2 or under indicates that the building requires moderate to substantial code compliance updates in order to protect the safety of the building's occupants.

Note: The building contains many conditions that do not comply with applicable codes.

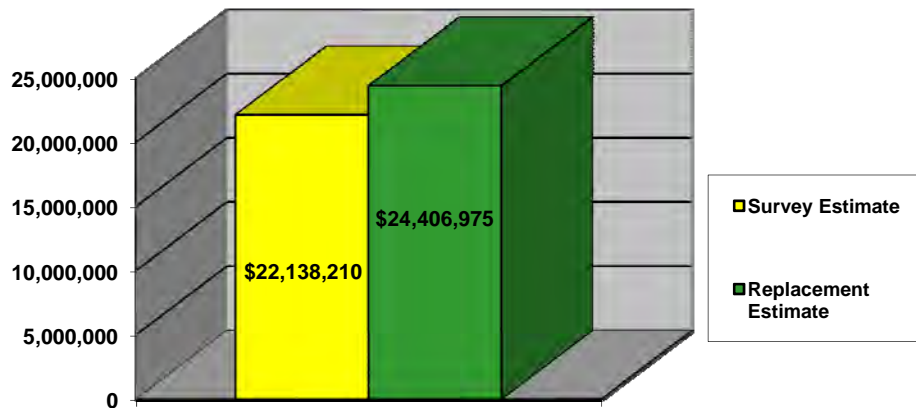
The chart below indicates the estimated value of the required work addressed by the building survey alongside the potential replacement cost. The replacement cost is provided as a guideline for comparative purposes and is based on replacing the building as is: size and use. Information considered includes the type of structure, year built and existing area for the building.

The required work addressed in this survey equates to approximately 90 percent of the cost of an entire building replacement project. Site acquisition costs for a potential new building were not factored into this comparison.

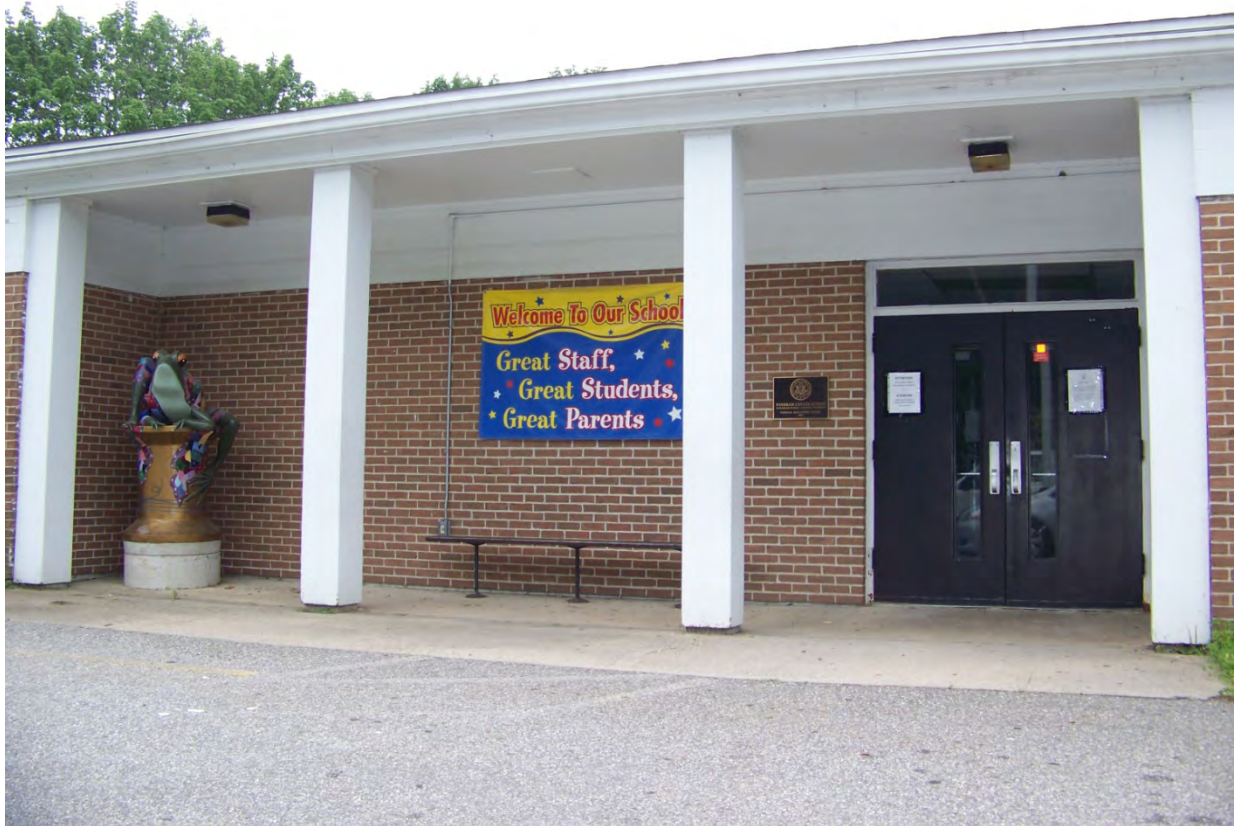
Windham Center School is housed in a one-story, 35,851 square-foot building located at 45 North Road (Route 14) in Windham Center. Originally constructed in 1953, the building received an addition in 1968 and serves Grades K - 5.

The building contains two sets of stairs and one ramp that lead up to the original structure. Circulation in the original building is provided by a central corridor. This is also the method of circulation for the 1968 classroom addition. These two structures are connected by two corridors, which enclose a courtyard. There are several means of egress on the building perimeter.

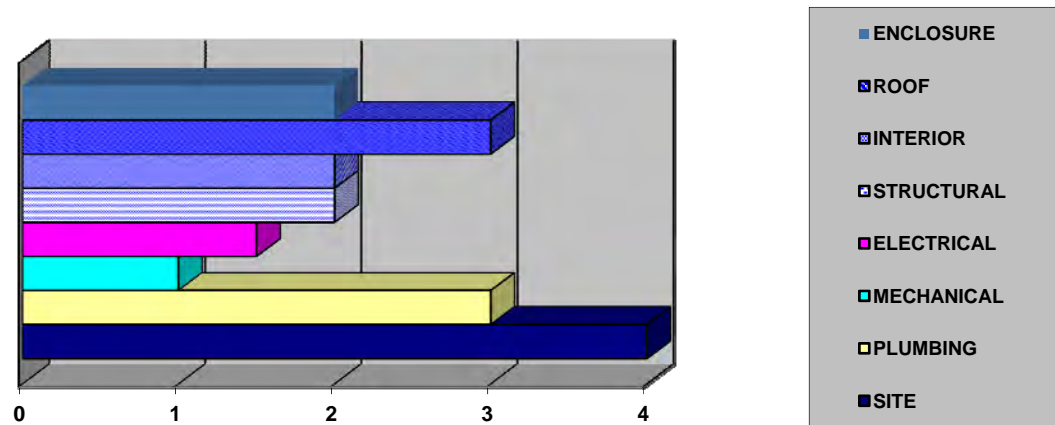
BUILDING CONDITION EVALUATION

Scale: 1 = Poor Condition, 4 = Excellent Condition

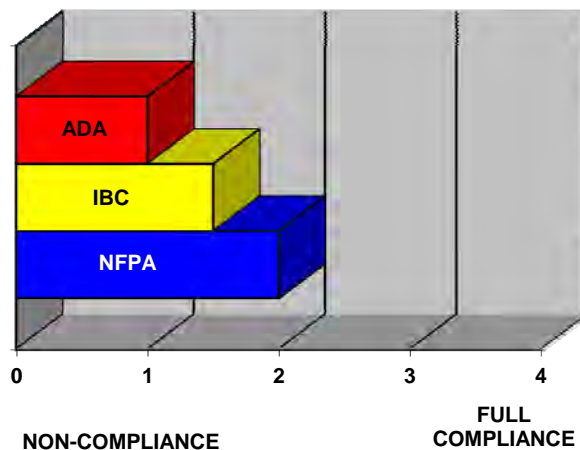
CODE COMPLIANCE EVALUATION

The graph below represents the building's overall conformity with IBC, NFPA and ADA requirements. Compliance was rated on a scale of 0-4, with a 4 rating equating to full compliance. A rating of 2 or under indicates that the building requires moderate to substantial code compliance updates in order to protect the safety of the building's occupants.

Note: The building contains some conditions that do not comply with applicable codes.

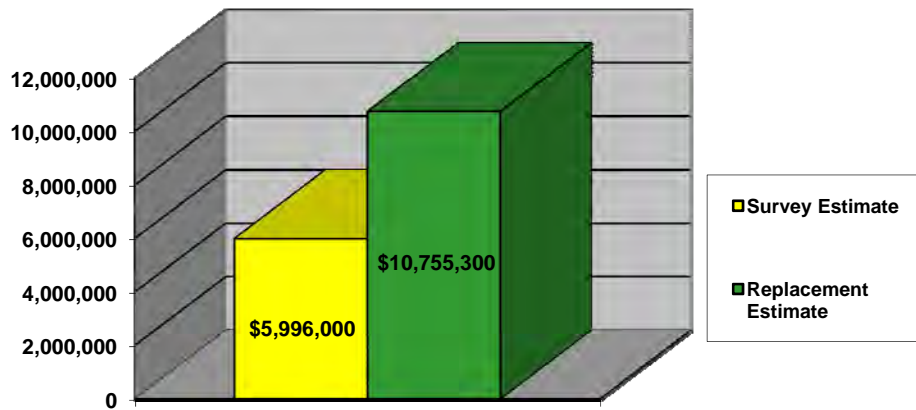
The chart below indicates the estimated value of the required work addressed by the building survey alongside the potential replacement cost. The replacement cost is provided as a guideline for comparative purposes and is based on replacing the building as is: size and use. Information considered includes the type of structure, year built and existing area for the building.

The required Alteration work addressed in this survey equates to approximately 56 percent of the Construction cost of an entire building replacement project. Site acquisition costs for a potential new building were not factored into this comparison.

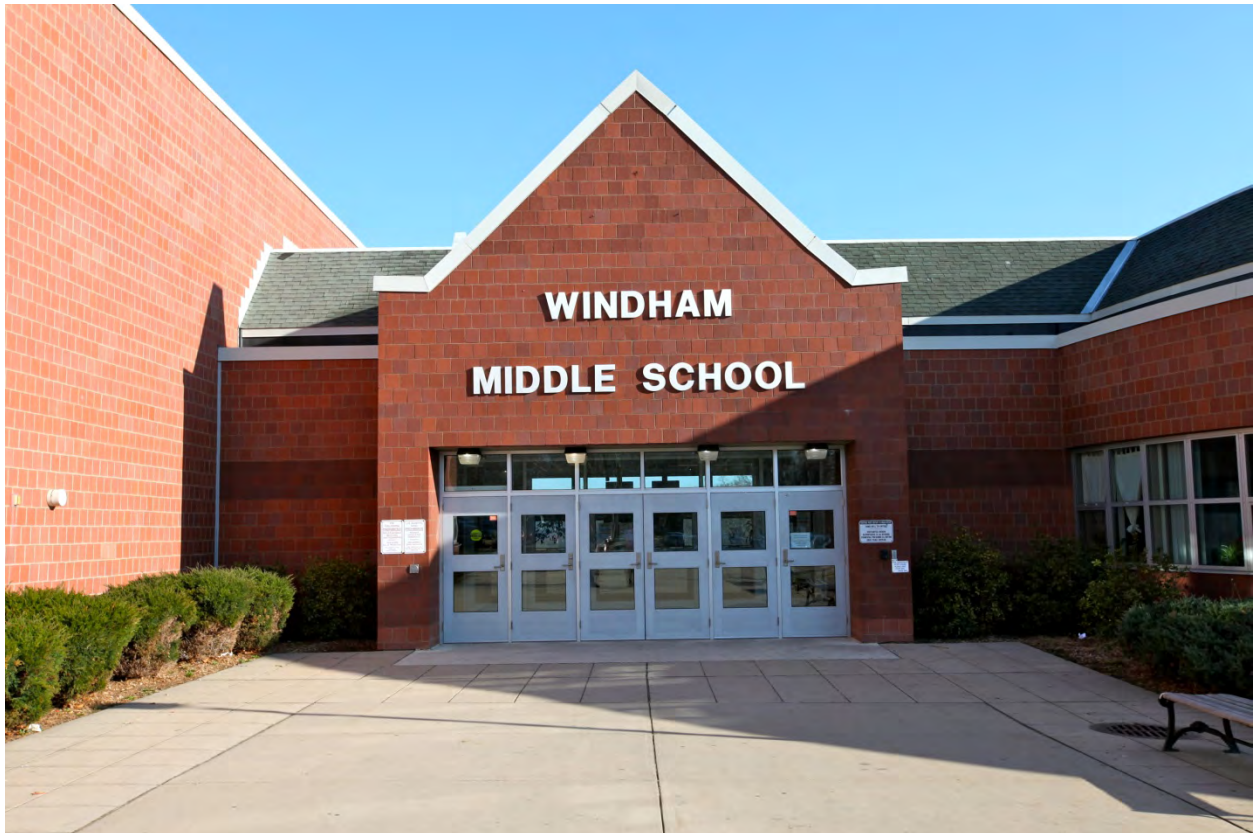
Windham Middle School is housed in a three-story, 179,076 square-foot building located at 123 Quarry Street in Willimantic. Constructed in 1996, the building serves Grades 6 - 8.

The building contains four stairwells and two elevators in the central part of the building. The west wing is a one-story gymnasium and related spaces. The east wing is two levels with an additional stairwell. Circulation in the central three-story area is provided by double loaded corridors surrounding a central bi-level courtyard.

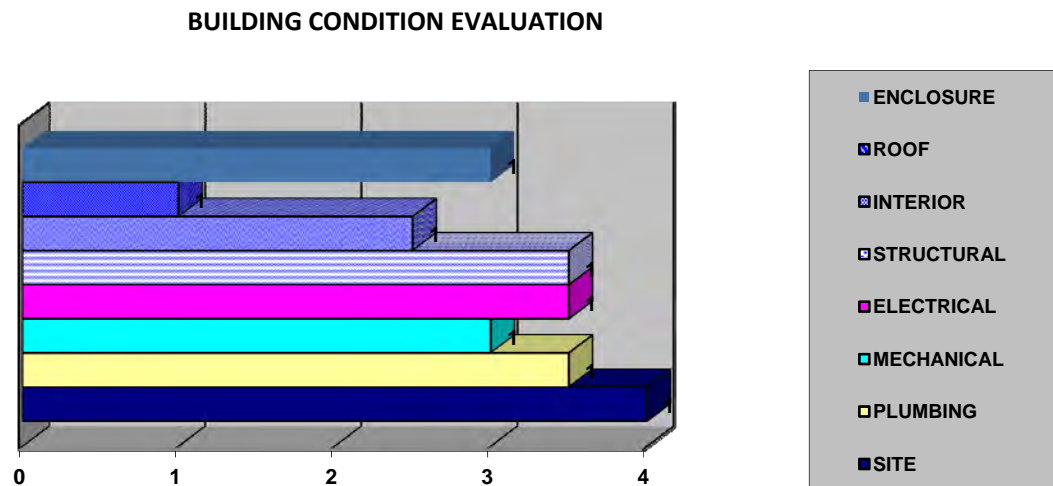
Each of the elements that were reviewed under this category was ranked on a scale of 0-4, with a 4 rating equating to excellent conditions. Components that received a ranking of 3 should be considered to be in good condition, while rankings of 2 and 1 are considered to be in fair and poor condition, respectively. The following chart graphically presents the survey results (reference Section 4 for a detailed description for each category).

Scale: 1 = Poor Condition, 4 = Excellent Condition

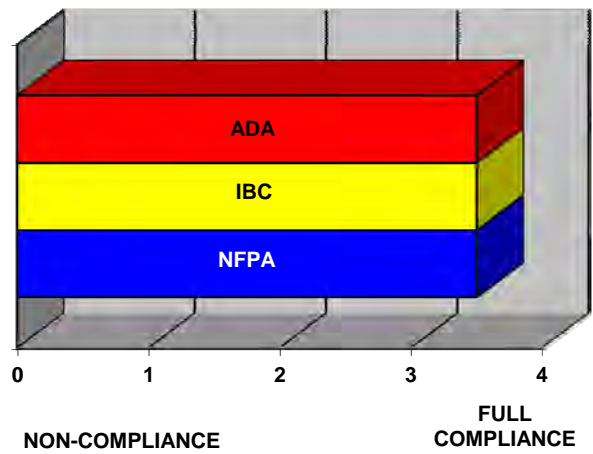
CODE COMPLIANCE EVALUATION

The graph below represents the building's overall conformity with IBC, NFPA and ADA requirements. Compliance was rated on a scale of 0-4, with a 4 rating equating to full compliance. A rating of 2 or under indicates that the building requires moderate to substantial code compliance updates in order to protect the safety of the building's occupants.

Note: The building contains some conditions that do not comply with applicable codes.

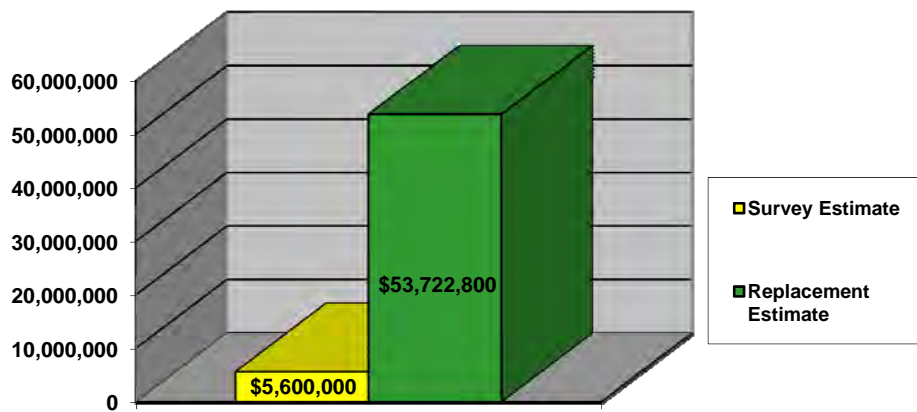
The chart below indicates the estimated value of the required work addressed by the building survey alongside the potential replacement cost. The replacement cost is provided as a guideline for comparative purposes and is based on replacing the building as is: size and use. Information considered includes the type of structure, year built and existing area for the building.

The required work addressed in this survey equates to approximately ten percent of the cost of an entire building replacement project. Site acquisition costs for a potential new building were not factored into this comparison.

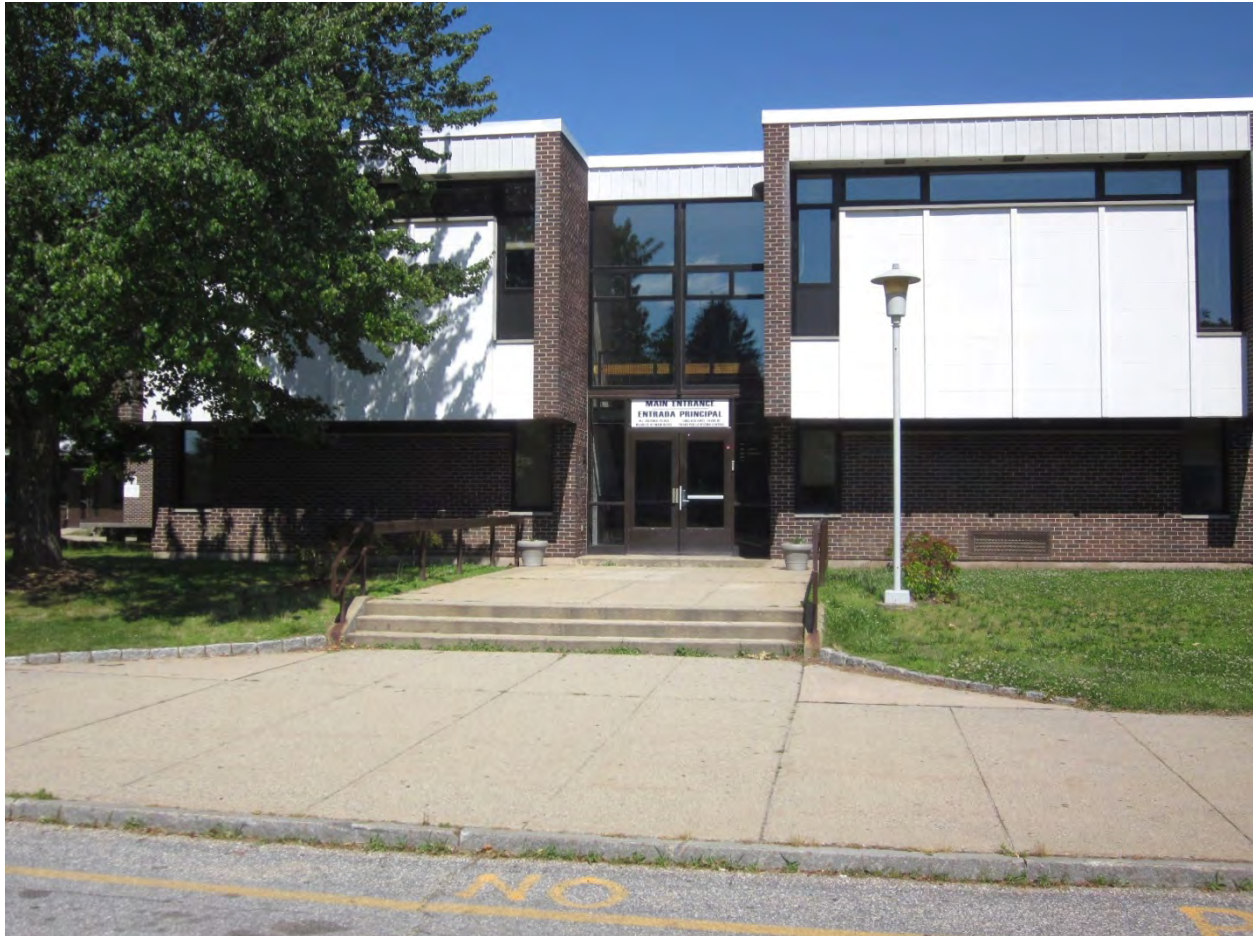
Windham High School is housed in a three-story, 226,765 square-foot building located at 355 High Street in Willimantic. The building was originally constructed in 1970 and serves grades 9 – 12.

The building contains nine stairwells and one elevator. There are two-levels of on-grade access to the building. The central part of the building contains classrooms and administrative space. Circulation in the central part is provided by a double loaded corridor, which surrounds a courtyard. Circulation in the northern side of the building is provided by a double loaded corridor which surrounds the auditorium. The southern end is a one-story section which provides access to the gymnasium and the pool.

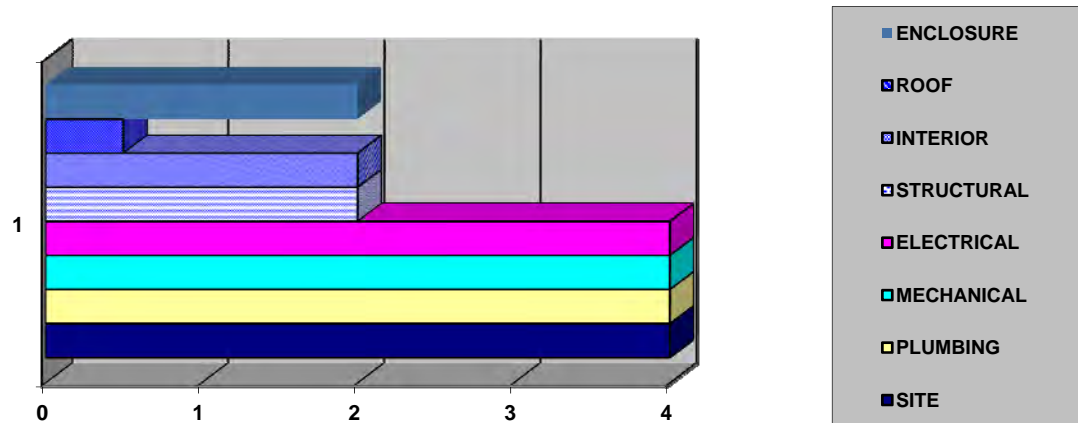
BUILDING CONDITION EVALUATION

Scale: 1 = Poor Condition, 4 = Excellent Condition

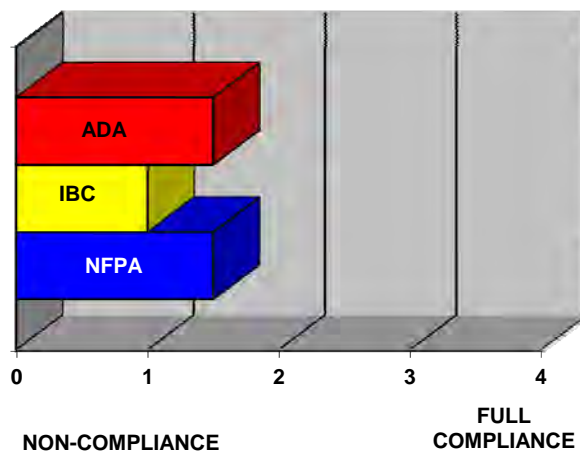
CODE COMPLIANCE EVALUATION

Note: The building contains many conditions that do not comply with applicable codes.

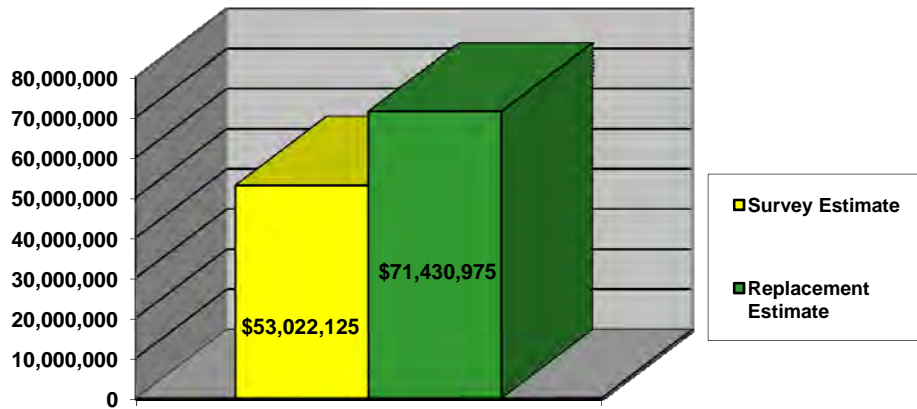
The chart below indicates the estimated value of the required work addressed by the building survey alongside the potential replacement cost. The replacement cost is provided as a guideline for The chart below indicates the estimated value of the required Phase III construction work addressed by the building survey alongside the potential replacement cost. The replacement cost is provided as a guideline for comparative purposes and is based on replacing the building as is: size and use. Information considered includes the type of structure, year built and existing area for the building.

The required work addressed in this survey equates to approximately 74 percent of the Construction cost of an entire building replacement project. Site acquisition costs for a potential new building were not factored into this comparison.

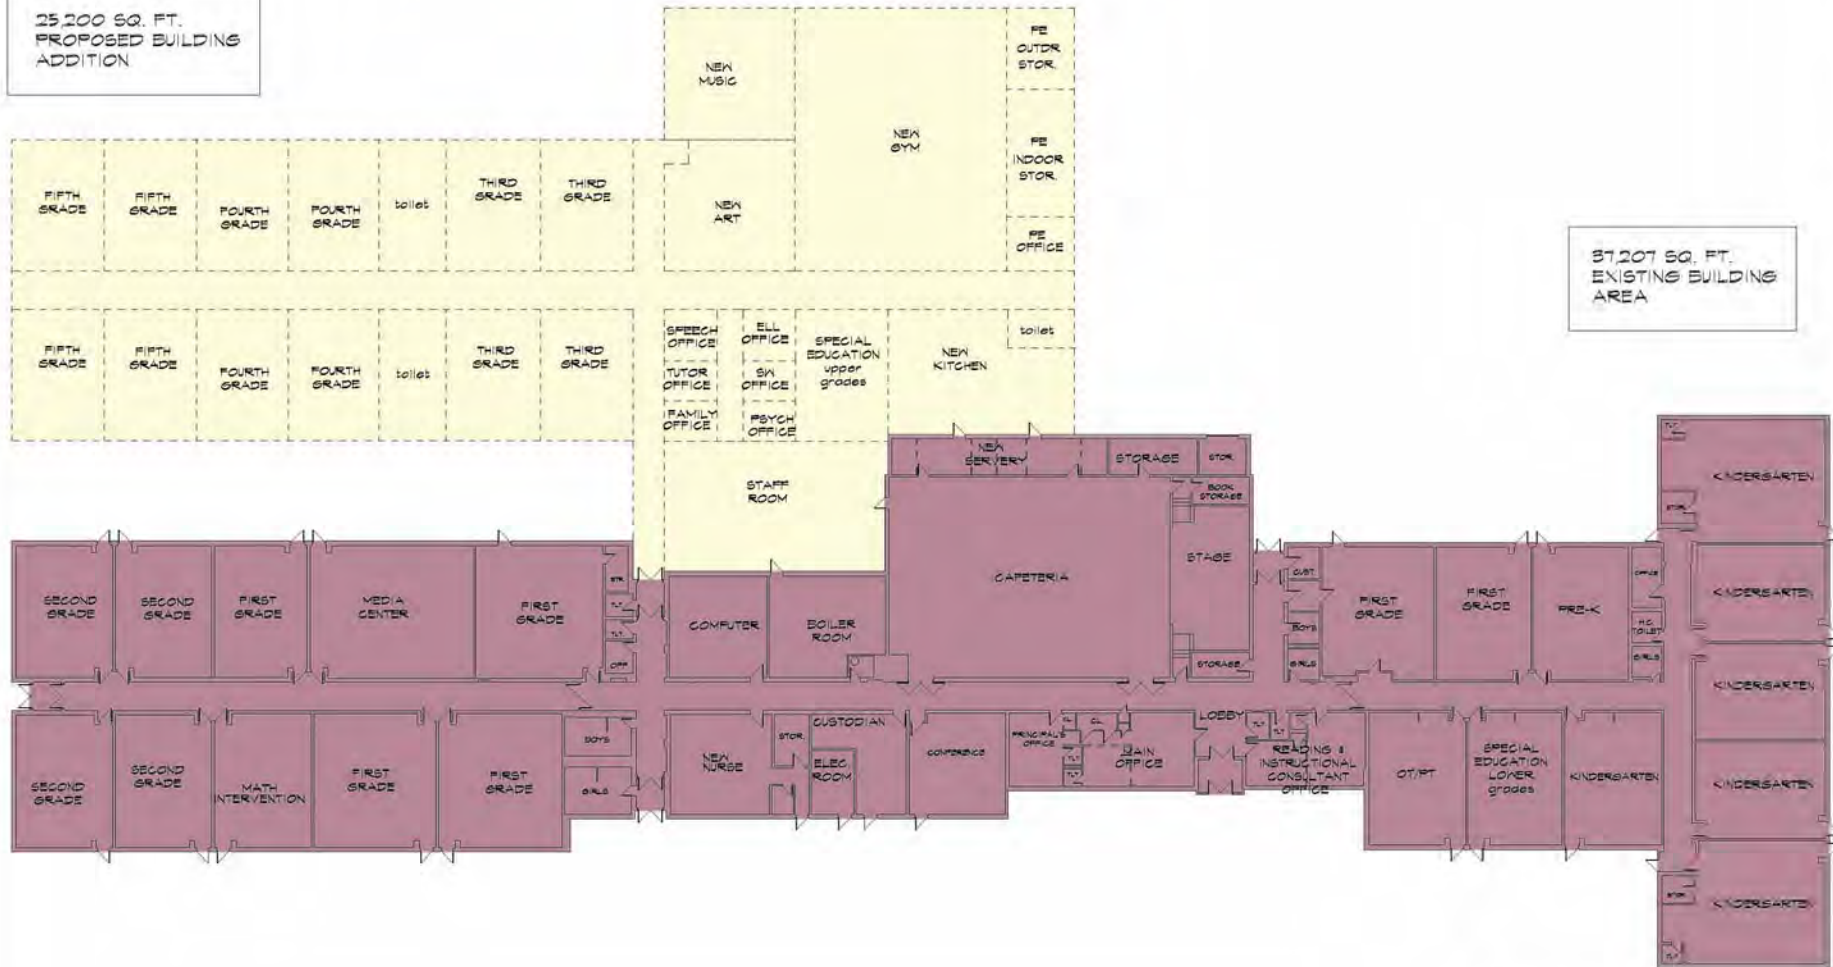
25,200 SQ. FT.
PROPOSED BUILDING
ADDITION

37,207 SQ. FT.
EXISTING BUILDING
AREA

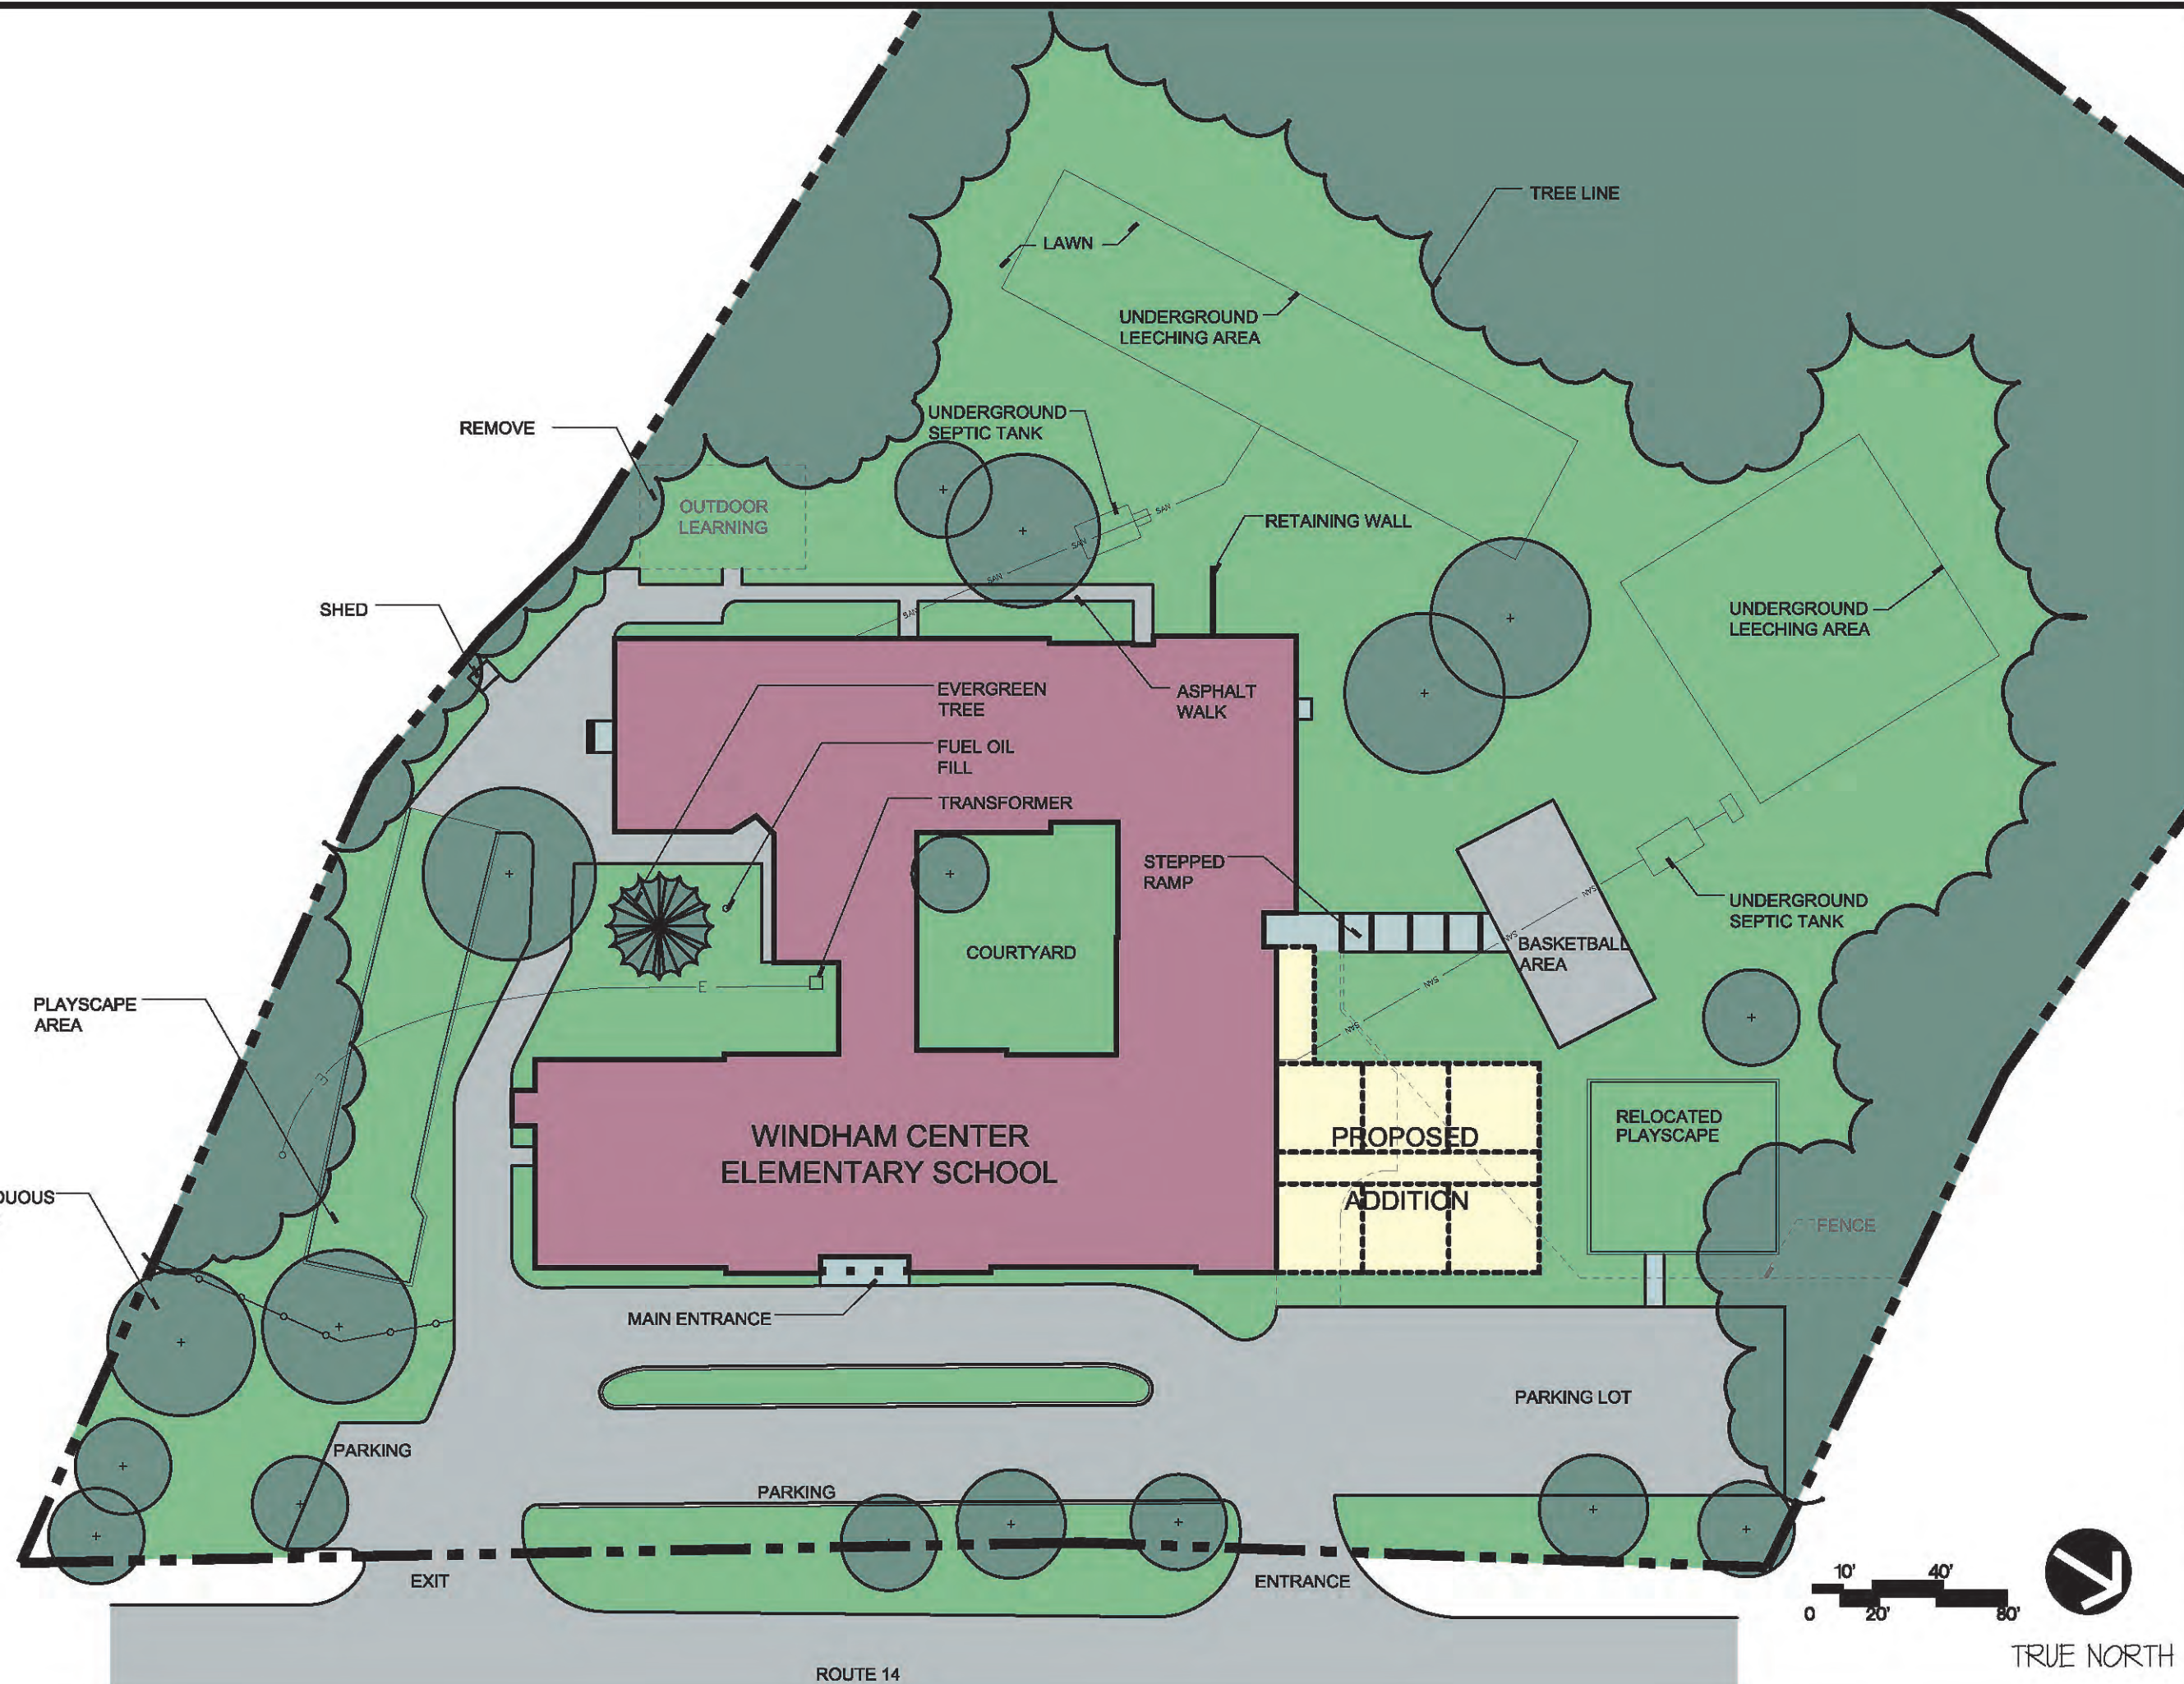
DATE:		SCALE: NTS	
PROPOSED		SITE PLAN	
WINDHAM CENTER SCHOOL 45 NORTH ROAD WINDHAM CENTER, CONNECTICUT			
FRIAR
